# FIRE ENGINEERING

APRIL, 1958

## Panic Piles Up the Dead in New York Loft Fire

24 garment workers victims of  
fire and explosion in Manhattan's high  
hazard district . . . nets save several

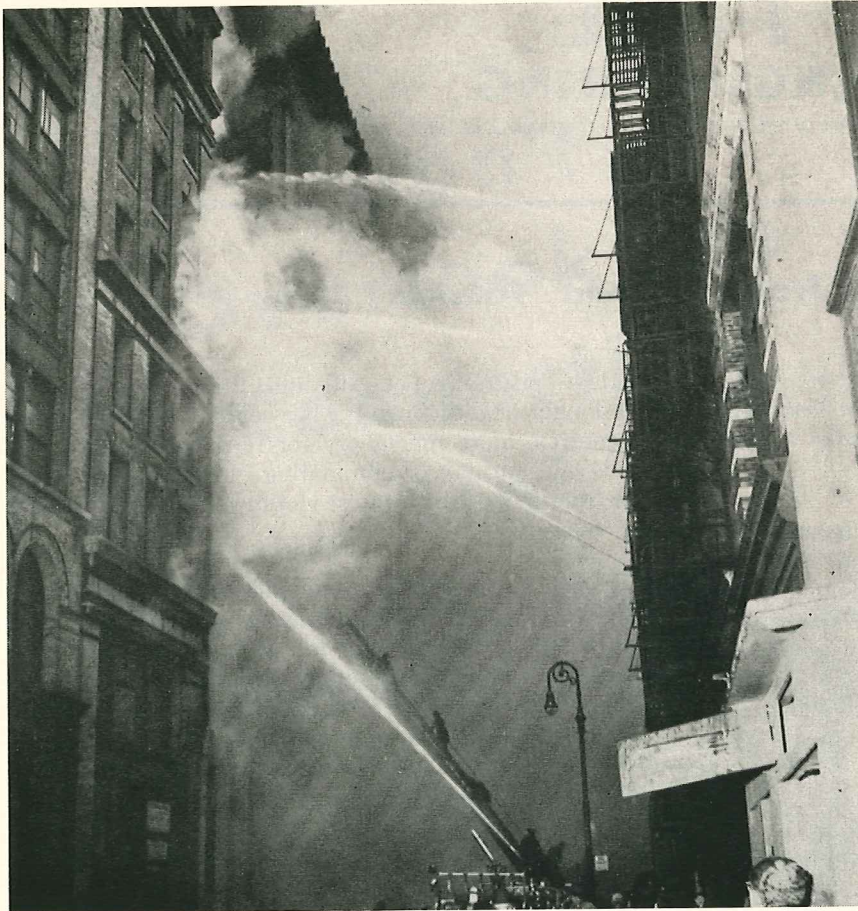
Heavy streams are directed into burning loft building from every vantage point in the rear (Mercer Street). Extreme depth of structure limited penetration. Men of Ladder 20 are shown

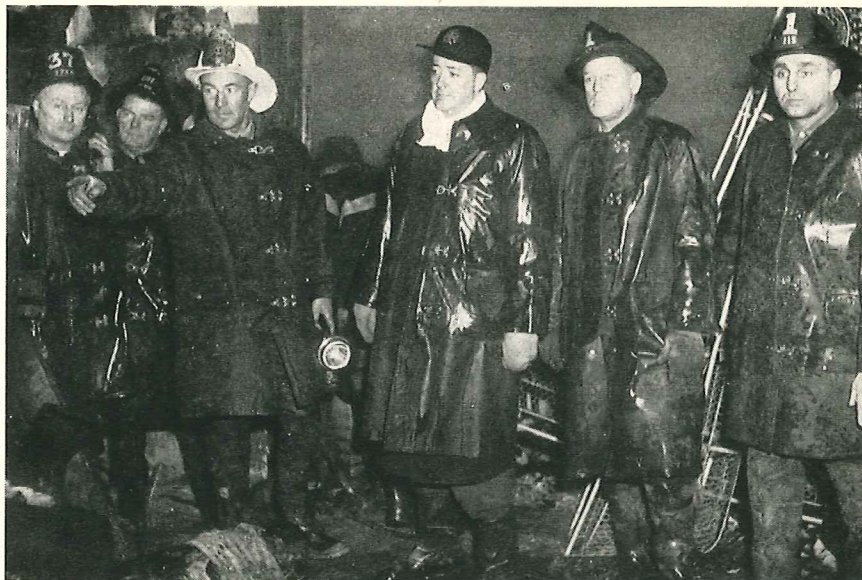
**Search for bodies goes on.** Deputy Chief Joseph Mackey, 1st Division, points out to Fire Commissioner Edward F. Cavanagh, Jr. where victims piled up on fourth floor of fire-gutted loft. Firemen in photo are unidentified

Ten bodies were found on the fourth  
floor beneath work benches of the under-  
wear company, by fire fighters who were  
able to enter the floor about an hour later.  
Five bodies were huddled together at a  
rear window on the Mercer Street side;  
and four bodies were piled on top of  
each other at the head of an unburned  
staircase on the same floor. The other  
deads were scattered about the premises.  
By 9:00 p.m., 23 bodies had been re-  
covered. Ambulances which responded

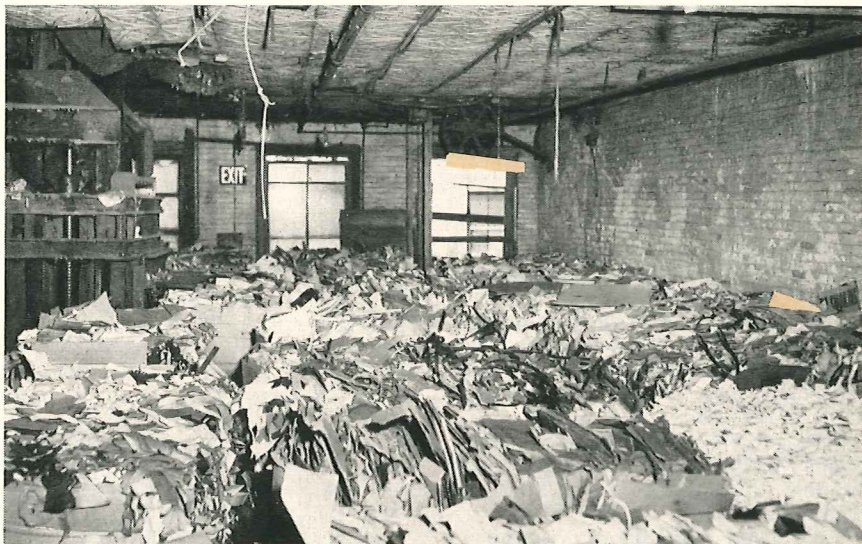
**What firemen are up against!** Violation uncovered almost across the street from fatal loft  
fire site as firemen intensified inspection efforts to clean up what Commissioner Cavanagh  
termed a "Fourth-rate, shabby, deplorable neighborhood"
