# Fire Engineering®

## Construction Concerns: Electrical Needs

Article and photos by Gregory Havel

*October 6, 2014*

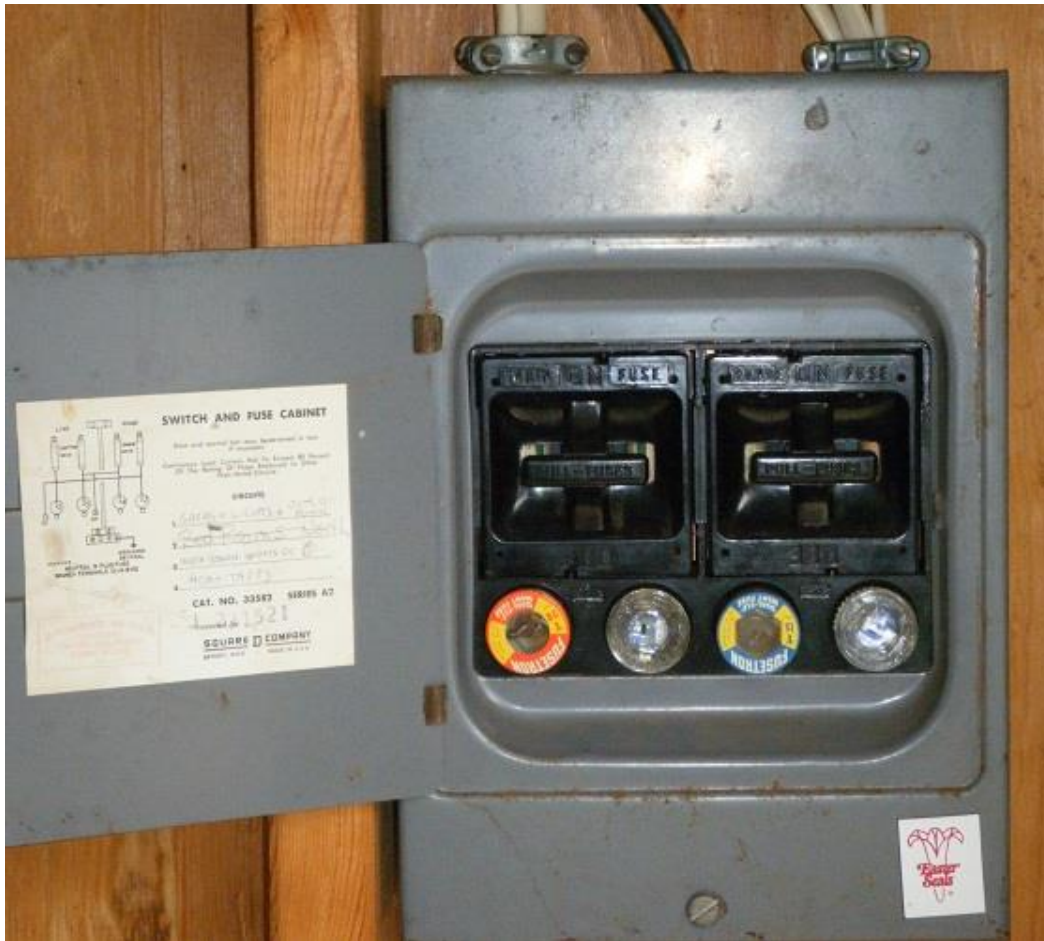
(1) Photos by author.

Photo 1 shows an electrical service panel that was typical in new residential and light commercial occupancies from the 1930s through the 1960s. These typically were fed by a 60-ampere 120-240 volt single phase service. The fuse block on the left was typically labeled "MAIN", and when pulled out disconnected the power to the plug fuse circuits below, but not to the fuse block on the right, typically labeled "RANGE".

If a fuse blew regularly, the homeowner would often run out of fuses of the proper capacity and replace it with one of a higher capacity. Or, just as often, a blown fuse was unscrewed and deliberately replaced with one of a larger capacity, which could overheat the wiring and cause a fire. This was simpler and less expensive than searching for the cause or installing additional circuits.

This type of service panel is still in use in some houses and other buildings. They are not a problem if they were properly installed, if they have not become corroded or if the connections are all kept tight, if the proper size fuse is used with the size and capacity of the wiring, and if they are still acceptable to the building officials.

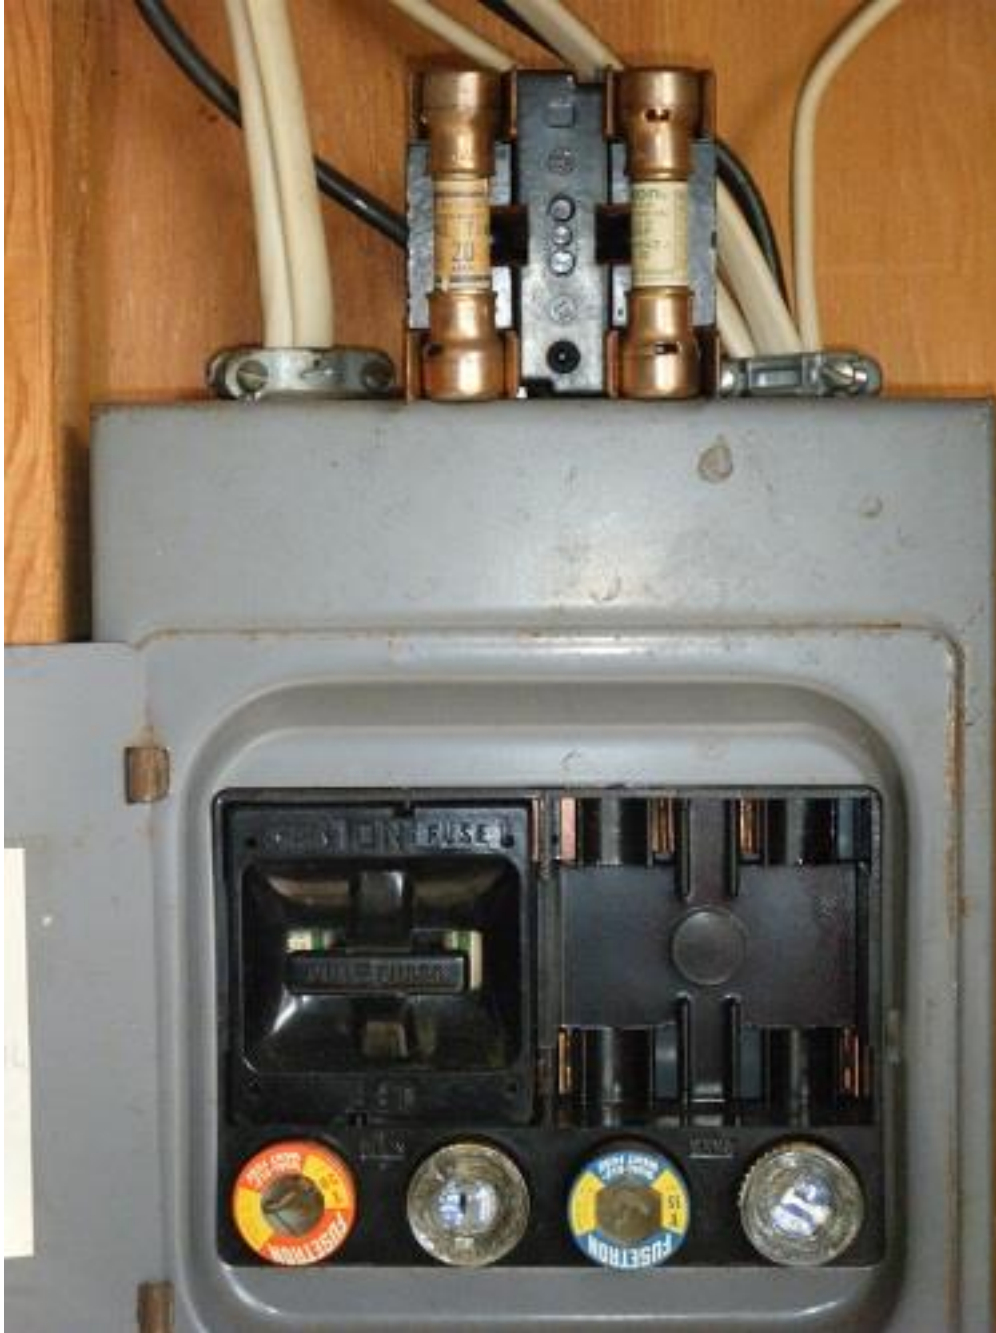
(2)

When these fuse blocks were pulled out, the cartridge fuses were exposed on their back sides, as shown in Photo 2. If there was no electric range, this fuse block could be used to provide power to another fuse box elsewhere in the house, or to a garage or other outbuilding. When a fuse block was inserted so that the word "ON" was right side up at the top, the copper blades on the fuse holders made contact inside the panel, and energized the fuses and wiring in the lower part of the panel. When the fuse block was inverted and inserted so that the word "OFF" was right side up at the top, the fuse block could be inserted, but no contact was made.

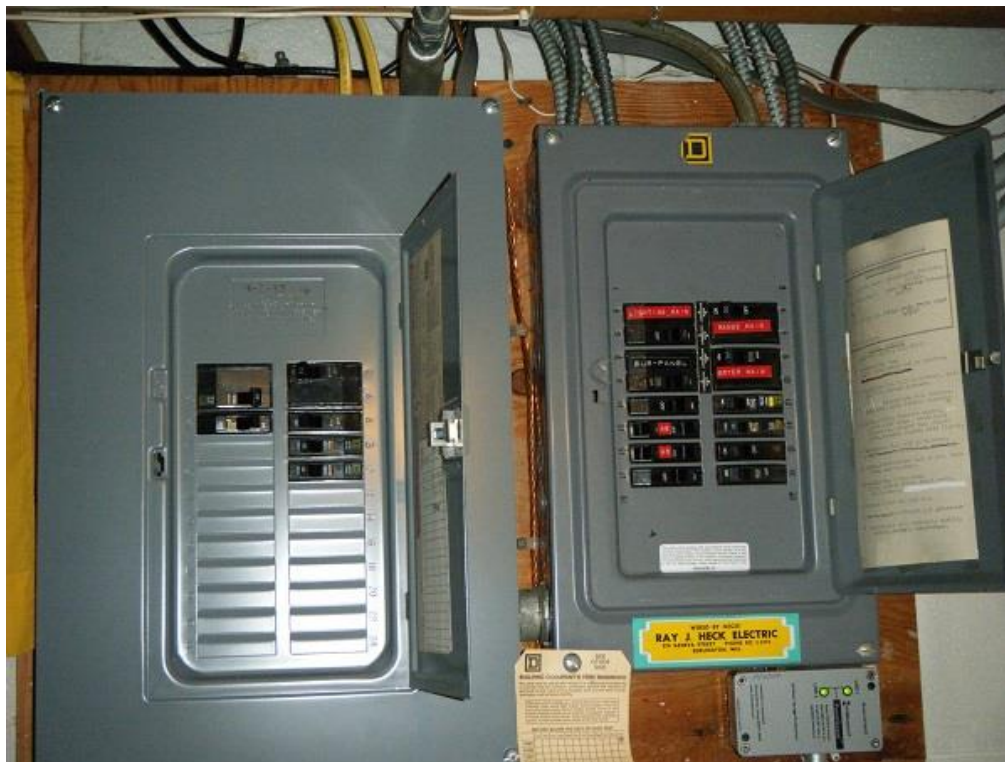
(3)

Photo 3 shows the electrical panel in a single-family house that was built in 1963. The circuit breaker box on the right is the original panel with a 100-ampere, 120- to 240-volt single-phase service. It has four MAIN breakers; each two-pole connects a 120-240 volt circuit. The upper left disconnects all of the single-pole circuit breakers below, the two-pole breaker below disconnects the subpanel to the left, the upper right two-pole breaker disconnects the electric kitchen range, and the two-pole breaker below it disconnects the electric clothes dryer.

Over the decades, the number of circuits in the original panel became inadequate because of the addition of more appliance circuits in the kitchen and in other parts of the house. In 1999, the subpanel to the left was added so that more circuits could be added as needed. The two two-pole circuit breakers at the top are not mains; one provides power to the central air-conditioner and the other provides power to the detached

garage. The single-pole circuit breakers in the subpanel are for dedicated appliance circuits in the kitchen and in other parts of the house.
