“Means of Egress”

For www.fireengineering.com

by Gregory Havel

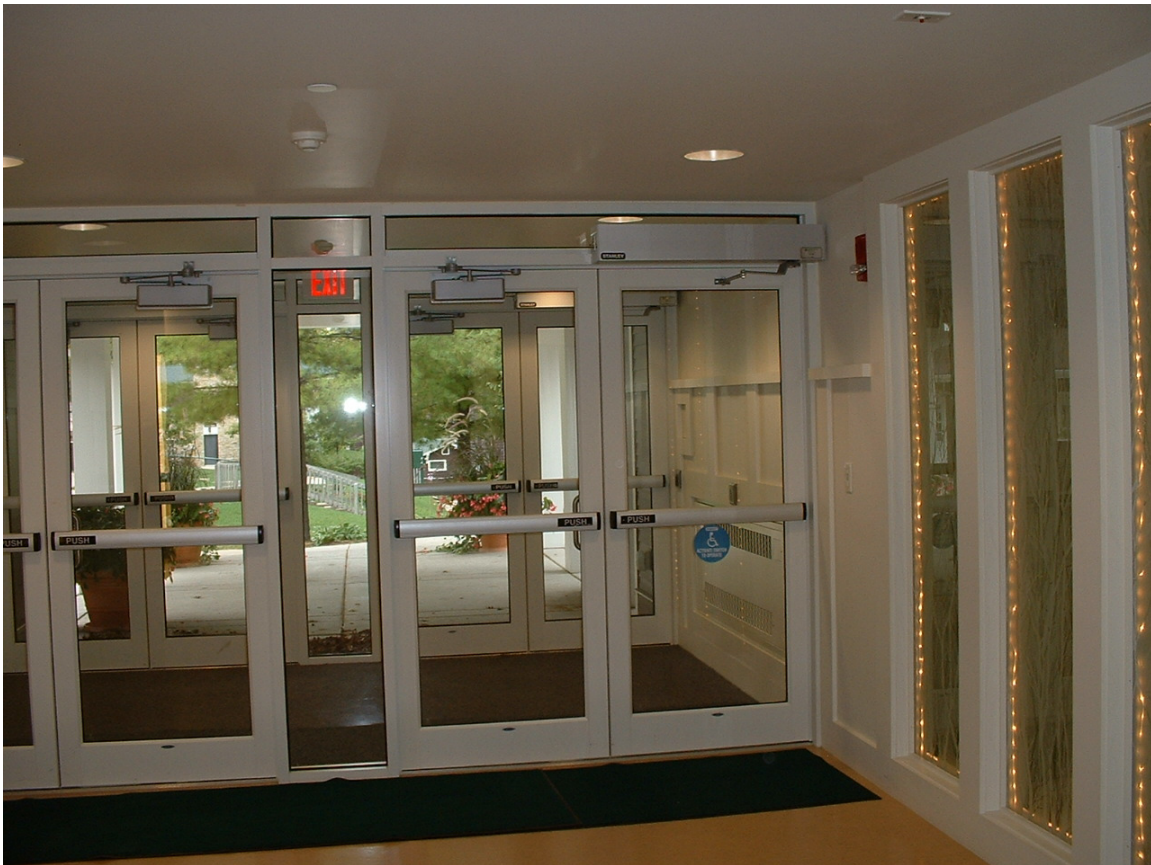
Photo by Author

The photo shows one of the required exits from the newly-renovated dining hall building at a university in southeastern Wisconsin. Many of the fire code and life safety requirements are visible. Most are included in NFPA 1—*Uniform Fire Code*; NFPA 101—*Life Safety Code*; and other NFPA codes and standards as noted. The life safety features include:

1 Unobstructed corridor: The corridor leading to the exit is unobstructed by storage, trash containers, housekeeping equipment, or potted plants.

2 Discharge at grade: The sidewalk outside the door is at the same level as the floor, and pitches away from the building to prevent accumulation of rainwater and ice build-up in winter. It leads from the building to a paved driveway on one end and a parking lot at the other.

3 Door opening out: The door opens outwards, due to the large number of people who can occupy the building.

4 Panic hardware: The door is held closed by a panic bar and latch. While a key may be needed at times to get into the building through these doors, occupants can exit at any time by pushing on the panic bar and opening the door.

5 Handicapped accessible doors: The door at the far right of each set of these exit doors is provided with a push-button and electric operator, for accessibility by visitors with impaired mobility, as required by NFPA 101 and the Americans with Disabilities Act.

6 Illumination: The corridor leading to the exit door has some light fixtures working even when the building is not open for business. The electrical system was installed as required by NFPA 70 *National Electrical Code*, as required by the State of Wisconsin.

7 Illuminated exit sign: The exit sign is lit by light-emitting diodes (LEDs) both day and night; has **emergency lighting capability**, and has a back-up battery inside the fixture in the event of a power failure. (NFPA 1, 101, and 70). Note the test button (in the rectangular plate on the ceiling at the upper right) for the battery back-up for the exit sign and emergency lighting feature of the fixtures that are lit in the photo.

8 Fire alarm pull station: Located near the exit in the vestibule on the wall at the right, as required by NFPA 1, 101, and the National Fire Alarm Code.

9 Fire alarm horn/strobe: While the alarm horns in the adjacent rooms and corridors are audible in this area, ADA and Life Safety Code require a flashing strobe to warn the hearing-impaired. It is located on the wall to the right of the doors, near the ceiling.

10 Fire alarm smoke detectors: Visible on the ceiling near the inner set of doors, and in the glass vestibule.

11 Wall heater: To dry the floor in the vestibule if it becomes wet, and to prevent the formation of ice in the winter.

12 Fire extinguisher: A fire extinguisher is provided near each exit from this building, and where needed to be not more than 75 feet of travel distance from anywhere in the building. (NFPA 10) The fire extinguisher cabinet is on the wall to the far left, and not visible in this photo.

13 Automatic fire sprinkler system: The sprinkler heads in this building are recessed and concealed. The cap covering the sprinkler head is visible near the smoke detector near the top left of the photo. There is a similar head in the glass vestibule, hidden behind the aluminum framing of the vestibule. (NFPA 1, NFPA 13 Fire Sprinkler Code, NFPA 101)

14 Safety glazing: The glass in both sets of the exit doors, as well as in the glass between the pairs, is tempered insulating glass. There are two panes of glass with a dry inert gas at low pressure sealed between the panes in each door and window. The glass is tempered, so that it is difficult to break. If it does break, it will shatter into small pieces like gravel, instead of breaking into razor-sharp shards and spears. The decorative windows into the dining room at the right are also tempered glass.
