Construction Concerns: Cornices and Parapets Article and photos by Gregory Havel

August 6, 2012

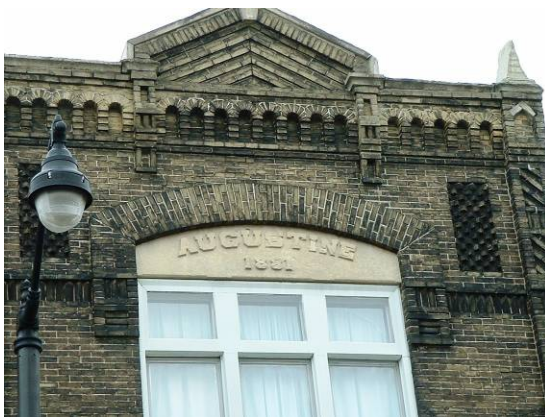
According to the dictionary, a “cornice” is a projecting horizontal member that tops an architectural component, like a wall or a column. A cornice can be made of masonry with simple or elaborate corbeling (photo 1), or it may be of another material that is attached to the face of the wall (photo 2). The word “cornice” was already used in Europe in the 1500s, although the architectural feature was in use hundreds of years before.

A cornice may be installed at the top of a wall at the roof line or on a parapet (photos 1, 2, 3). A cornice may be part of the original building design, or it may have been added later to change the appearance of the building. In any case, a cornice places an

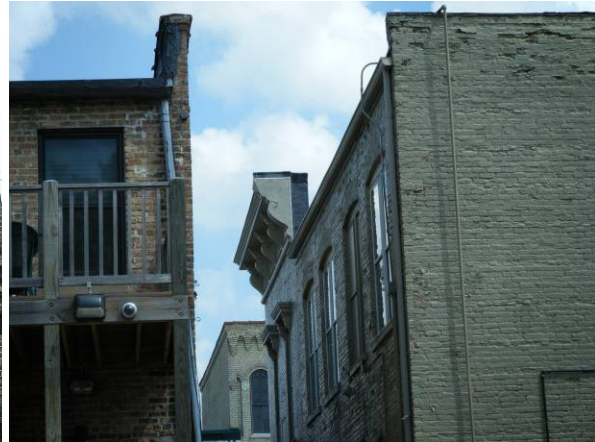
Since parapets are exposed to the weather on both sides, they tend to deteriorate and weaken more quickly than a wall that is exposed to the weather on only one side (photo 2). This simple fact makes them liable to fail in earthquakes, high winds, and under impact from firefighting hose streams. When they fail, they can collapse onto the roof (endangering anyone who is inside the building on any floor) or onto the sidewalk or street (endangering anyone who is below). When the deterioration of a parapet is advanced, it may lean toward the roof or the outside of the building (photo 3).

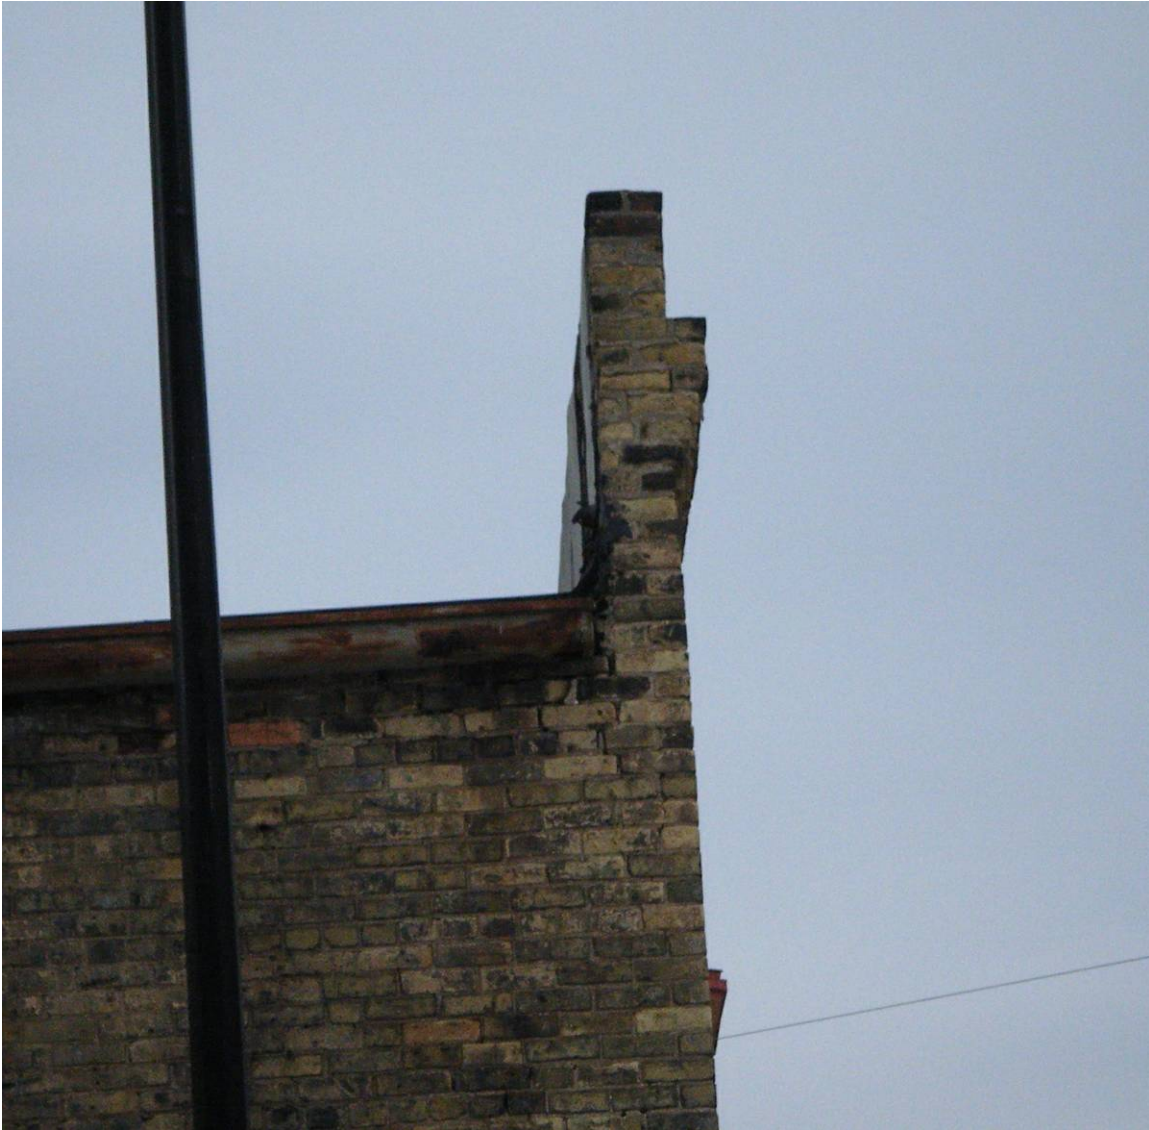
According to the dictionary, a “parapet” is a wall that protects the edge of a platform or roof (photo 3, next page). It is usually made of the same material as the lower part of the wall. The word “parapet” was already used in Europe in the 1500s, although parapets were used in ancient Roman and Greek fortifications thousands of years earlier, for the protection of defenders on top of the main wall.
