TRADITIONS TRAINING, LLC.

“COMBAT READY” FIREFIGHTING
FIREGROUND PROVEN TIPS, TECHNIQUES & DRILLS

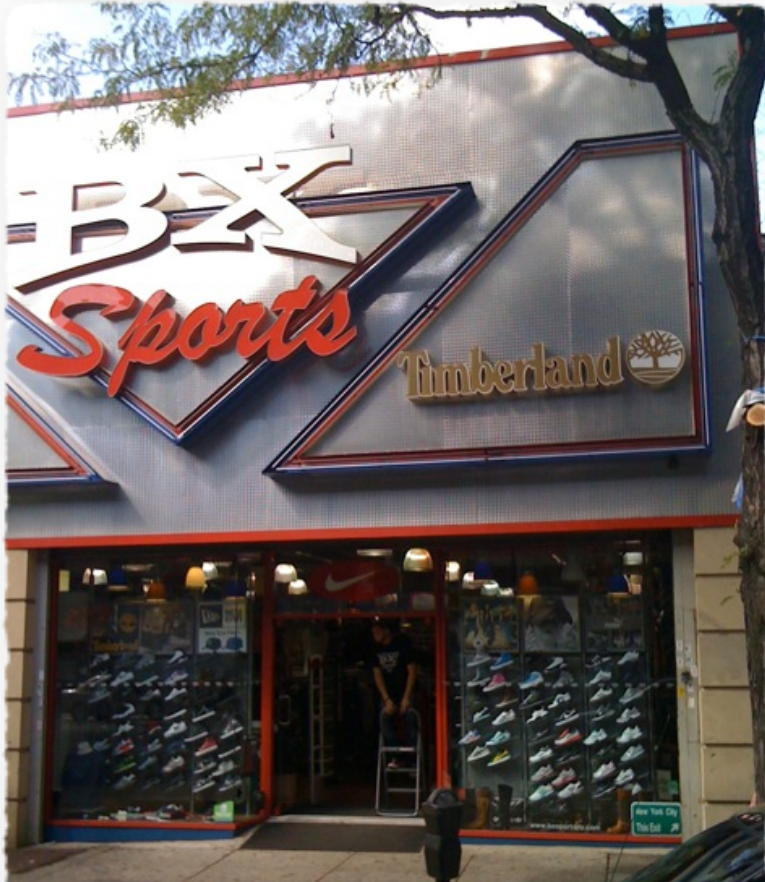
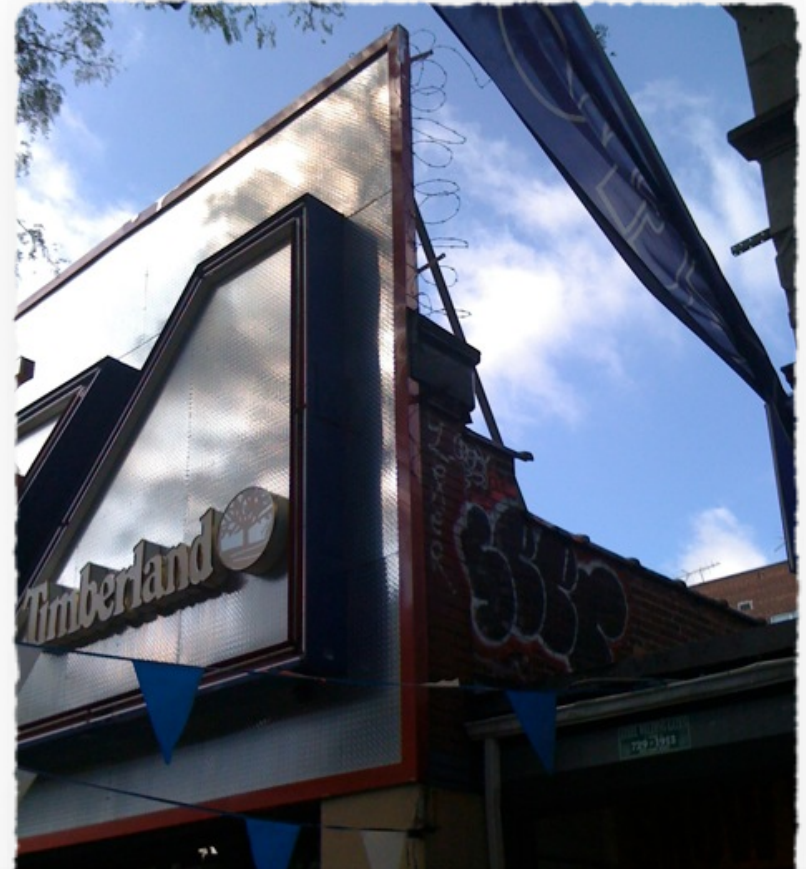
Note: these 2 photos show a dramatically different view of a potential fire building. From the front, perhaps the illusion of a 2-story building. A quick look at the corner yields a dramatically different viewpoint. Note the added signage & structure attached to the original building parapet and roof. This signage must not be overlooked. Any fire entering the cockloft space will dramatically impact the ability of the building to carry the additional load of the massive diamond-plate sign. Also to note, placing a ladder to the front of the sign for roof access would result in a 10' drop from the ladder down to the roof and attempting access from the corner may be delayed due to razor/barbed wire.
