Fire Engineering®

Construction Concerns: Proscenium Fire Curtains

By Gregory Havel

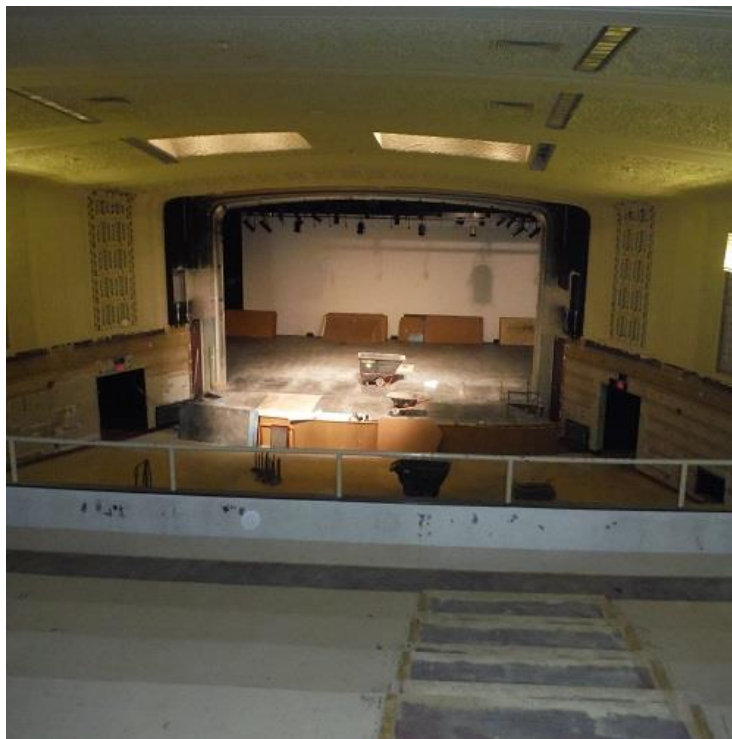
(1)

Photo 1 shows the interior of a secondary school auditorium with a complete stage with fly gallery fully equipped to produce stage plays. This was built around 1930, and it is undergoing renovation. The main floor has a seating capacity of about 700 (like the Iroquois Theater), but it has only one balcony.

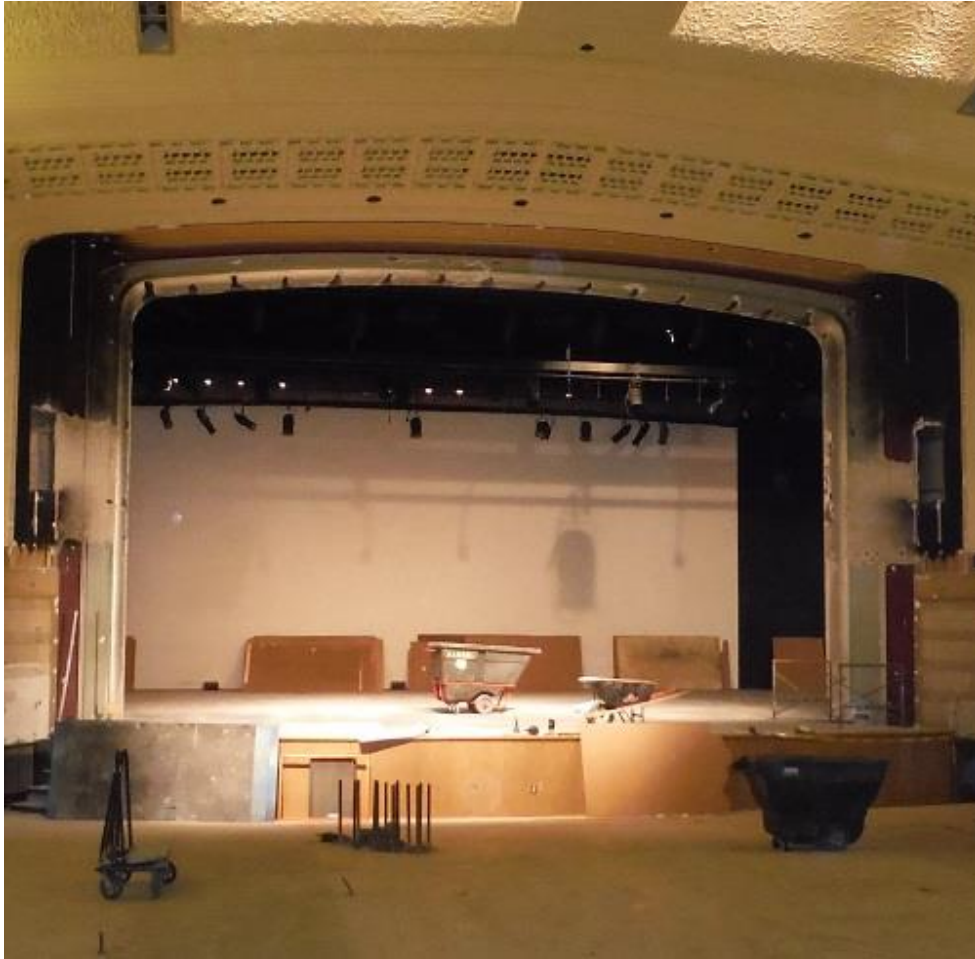
(2)

Photo 2 shows the terra-cotta masonry proscenium arch at the front of the stage with some of the fly gallery hoists (with stage lights) toward the rear.

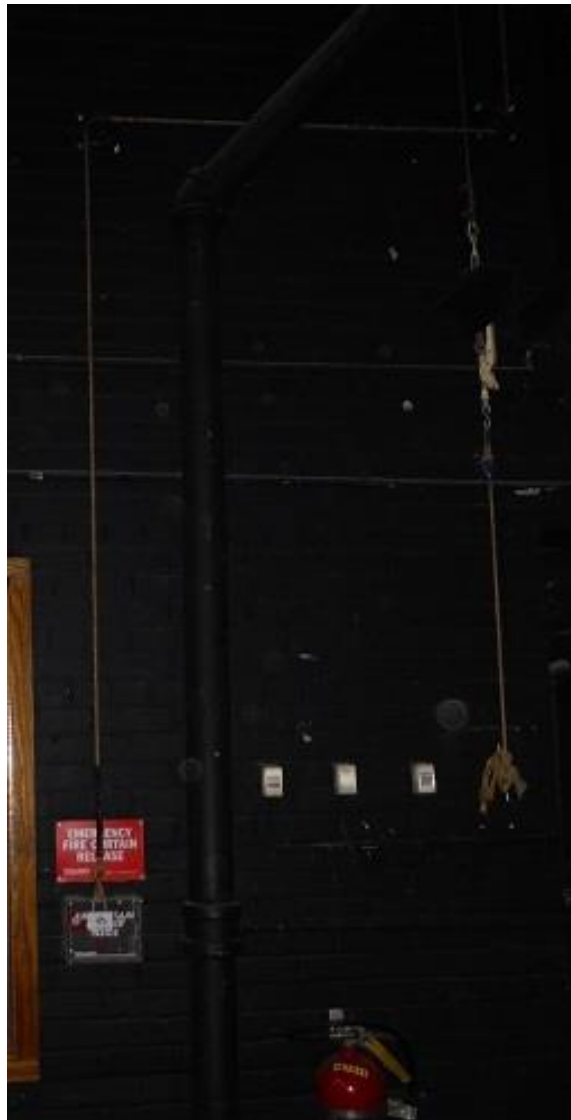
(3)

Photo 3 shows one of the manual release devices for the fire curtain at stage level. There is one of these on each side (stage left and stage right) of the proscenium arch. The activation of either will allow gravity to drop the fire curtain from above, where it hangs in accordion pleats behind the top of the proscenium arch.

Please note that the fire curtain release features shown may not meet the requirements of present-day codes and standards for facilities equipped for theatrical production.

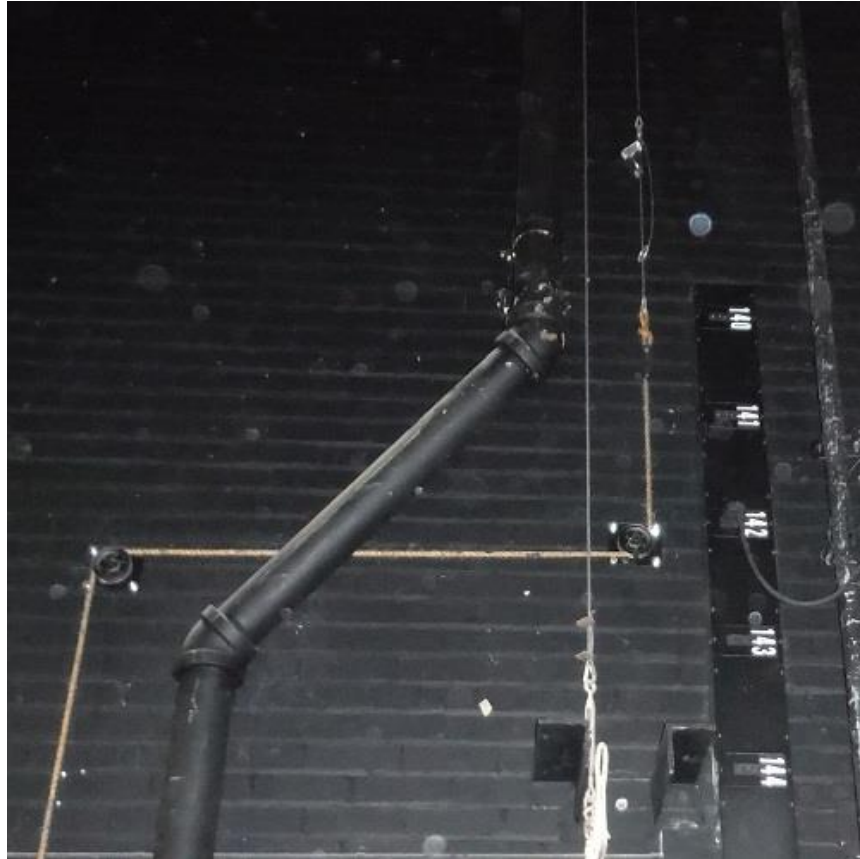
(4)

Photo 4 shows another view of the manual release and its connection to steel cables with fusible links on each side of the proscenium arch and at the top. Releasing the cable tension either manually or by a melted fusible link will allow gravity to drop the fire curtain.
